DIVISION Power Systems
TM 7972:70-622
DATE 21 April 1970
W.O. 1475-78-2000

TECHNICAL MEMORANDUM

TITLE: Development and Production of Explosively Bonded 316SS/Tantalum Tubing

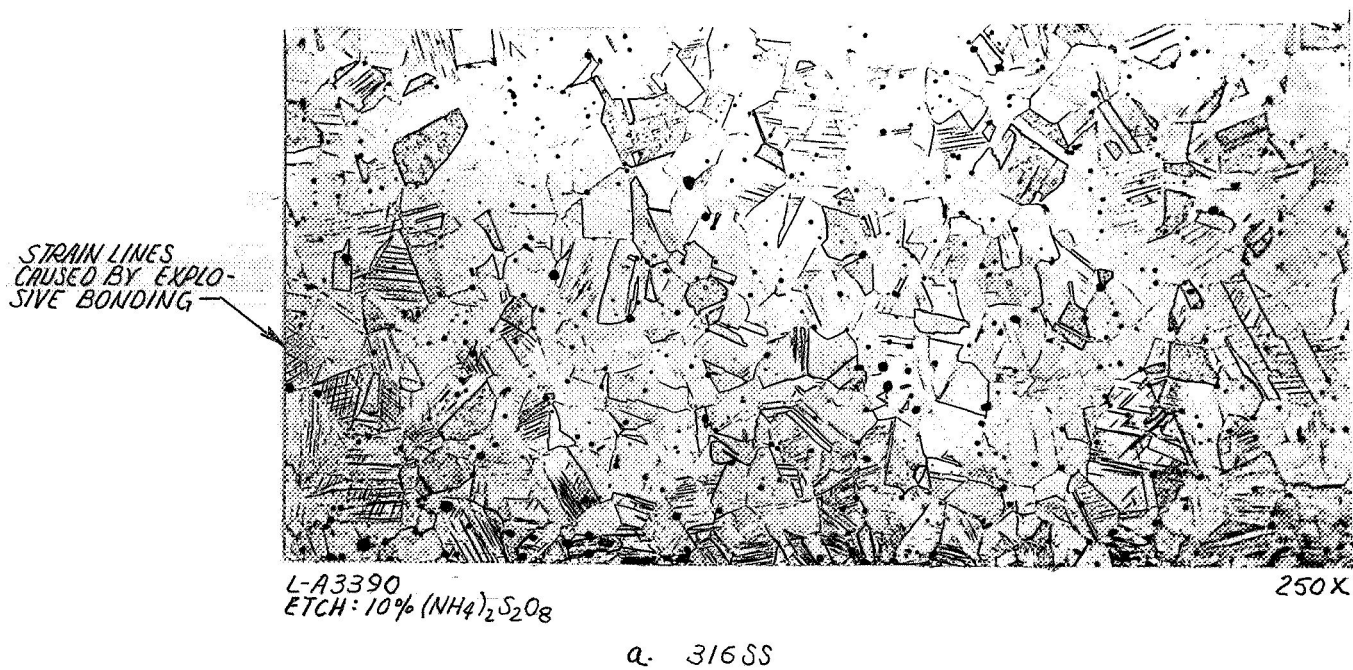
MICROSTRUCTURE OF 316SS AND TANTALUM AFTER EXPLOSIVE BONDING

The hardness of both the 316 SS and Ta increased due to explosive bond fabrication, Figure 14, with the greatest hardness increases adjacent to the 316 SS/Ta interface, the region of highest absorbed energy from the explosive shock impact. Visible strain hardening of the 316 SS is apparent, Figure 15, but no visible microstructural changes are apparent in the Ta.

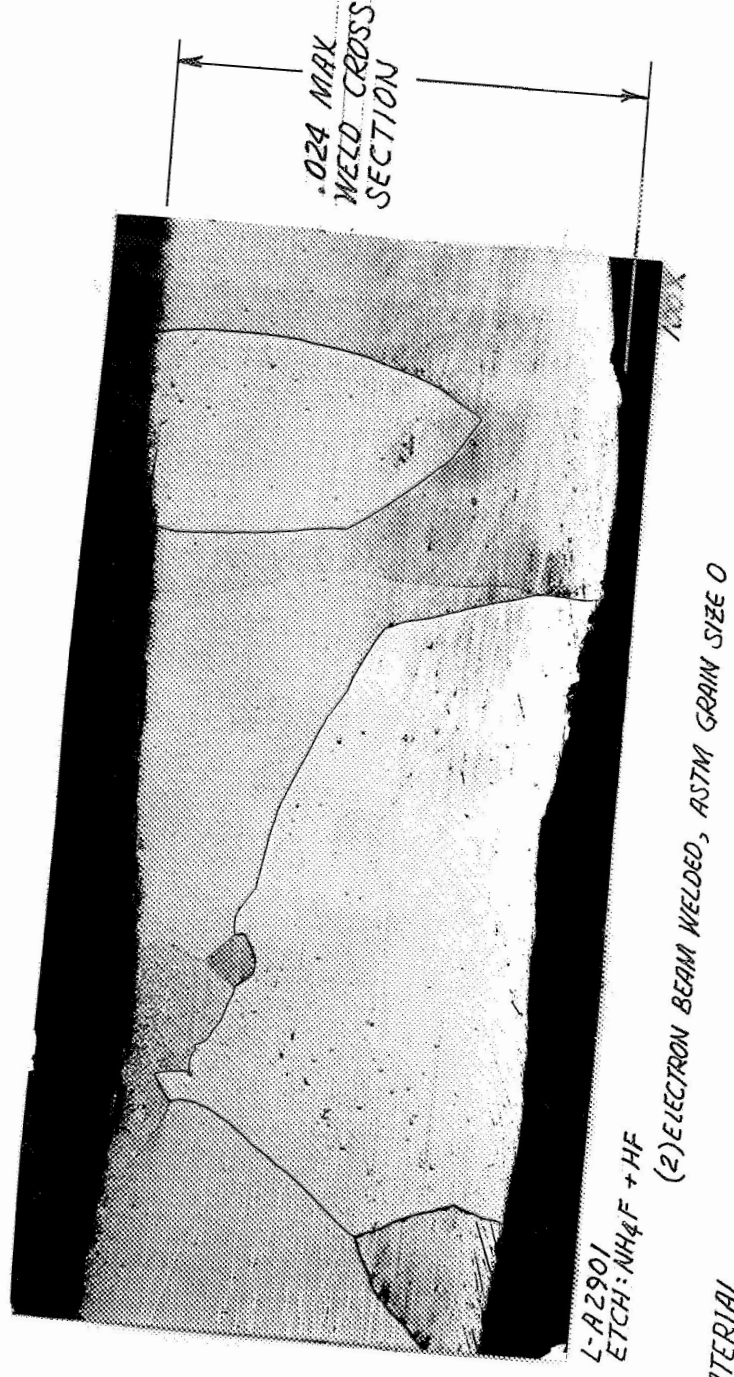
b. KAWECKI SUPPLIED MATERIAL

a. FANSTEEL SUPPLIED MATERIAL

MICROSTRUCTURES OF PARENT AND ELECTRON BEAM WELDED TANTALUM TUBING
